Shimanto River Environmental Survey

Shimanto River and Kubokawa Area

3 July 2022

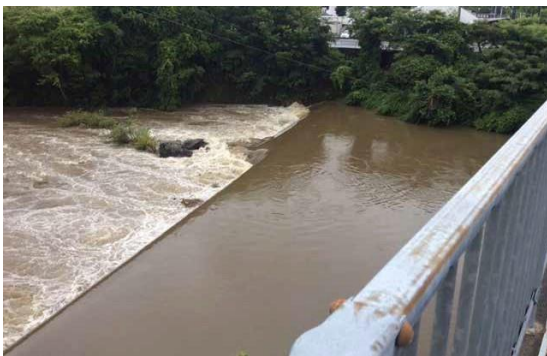
Photograph 1: Near roadside station by the Niida River, 3 July 2022

Turbid water volume increased due to Typhoon No. 4 and overflowed from the weir.

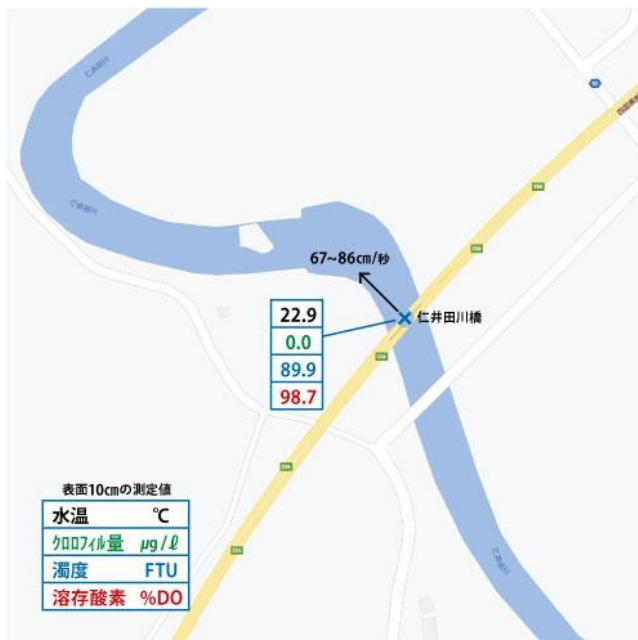
Chart 1: Chlorophyll content, turbidity, dissolved oxygen and current direction and velocity at the Niida River Bridge

The turbidity (FTU) was extremely high at 89.9 FTU. This is thought to be due to mud flowing into the river water, which caused the high turbidity (FTU). There was no chlorophyll content at all (zero $\mu\text{g} / \ell$). It is assumed that the flow was too fast to produce chlorophyll content and that there was no stagnant space. The oxygen content was 98.7%, indicating that there was sufficient oxygen dissolved in the water.

(1) It is necessary to search for the source of muddy water runoff and consider measures to prevent soil runoff, which causes the muddy water. The survey was conducted during abnormal weather conditions caused by an approaching typhoon, which resulted in an extreme increase in water volume, and this definitely affected the water quality, volume, and velocity of the river. The most affected measurement was turbidity (FTU).

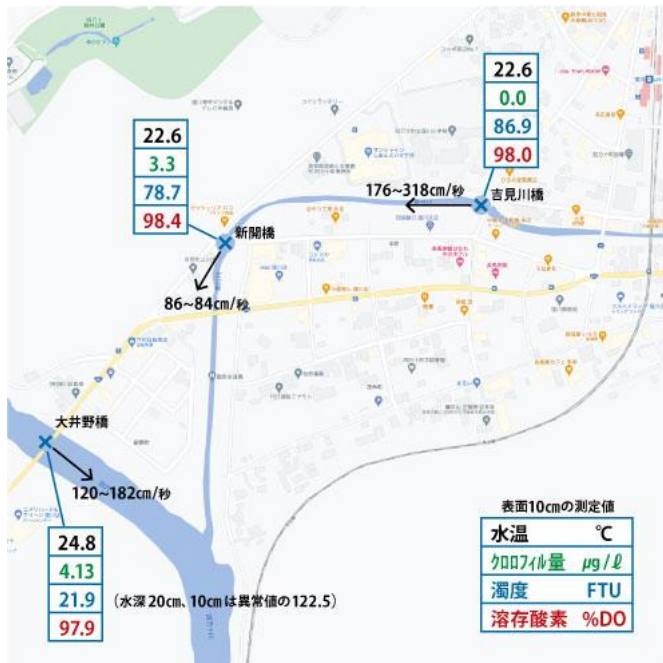
Chart 2 : Rhlorophyll content, turbidity, dissolved oxygen and current direction and velocity at the Yoshimi River, Shinkai Bridge and Oino Bridge on 3 July 2022

Chlorophyll levels were completely absent in the vicinity of the Yoshimi Bridge, as was the case at the Niida Bridge.

However, the Shinkai and Taiino Bridges showed higher values of 3.3 $\mu\text{g} / \ell$ and 4.1 $\mu\text{g} / \ell$, respectively.

Turbidity (FTU) was also remarkably high near Shinkai Bridge at 78.7 FTU. The dark brown water color is mostly due to mud. It is also important to determine the source of these muddy waters. Mud has no positive effect on organisms. The turbidity (FTU) is characterized by abnormally high levels at all sites. It is thought that the typhoon caused an increase in water volume, and water-laden sediments were washed into the river. It is

necessary to determine whether this is from river construction sites, farmlands, and roads, and where are the high and low points where soil runoff occurs. Excessively high turbidity (FTU) may be evidence that sediment is being wasted into the river and ocean. This can lead to disturbance and degradation of terrestrial, riverbank, and coastal ecosystems.

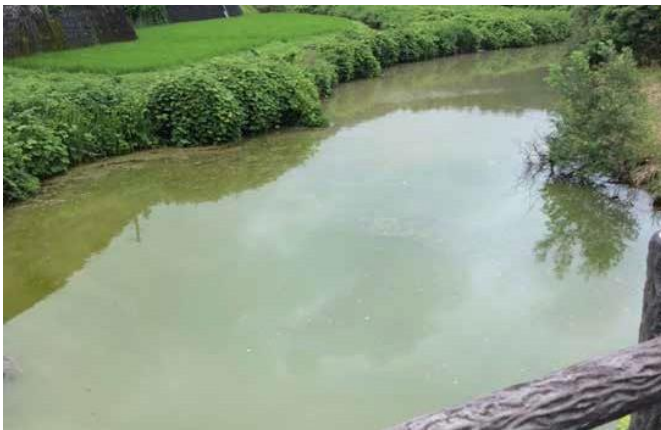
The turbidity (FTU) was so high near the mouth of the Iechi River. An elderly woman (in her 80s) in the neighborhood told us that there were three ginger farms and several rice farms upstream, and that pesticide and fertilizer runoff from these farms may have caused the turbidity (FTU).

Photograph 5: Aggravated water quality near the mouth of the Iechi River. The water color is brown compared to that of the Saga Wier lake (blue color). Some floating trashes are observed. 3 July 2022

(2) It was suggested that the high turbidity (FTU) values in the Iechi River may also be caused by agricultural activities such as ginger farming. A survey of agriculture in the upper reaches of the Iechi River will be necessary in the next and subsequent surveys.

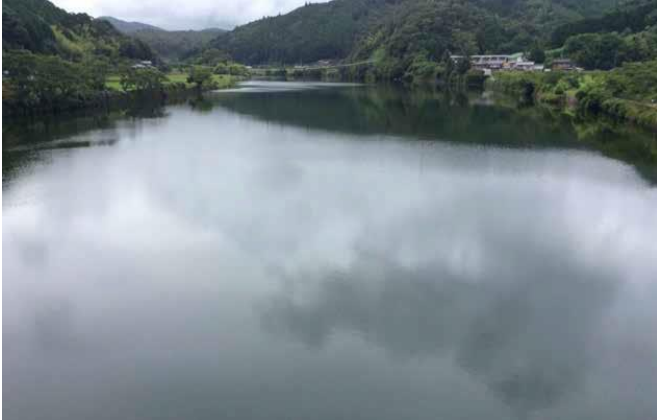
Photograph 6: Saga Wier Lake on 3 July 2022

Water flow within the Saga Weir was stagnant and had almost no velocity (see Figure 3). However, the chlorophyll content was also high, but the chlorophyll content at the point where the Iechi River flows into the Saga Weir Lake was the highest at $23.1 \mu\text{g}/\ell$, and the turbidity (FTU) was even higher than in the weir at 10.3 FTU. The water quality of the Iechi River, which flows into the Saga Weir, was even dirtier with visible turbidity in comparison (See Photo 6).

Although extremely turbid and muddy water was flowing in from the Kubokawa area and Iechi River upstream, at this point (around 1:30 p.m. on July 3), there was still no inflow of turbid water caused by the typhoon.

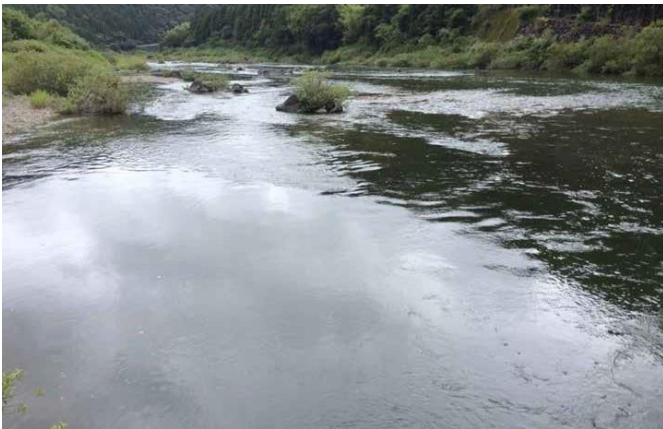
Turbidity within the weir ranged from 1.4 to 2.2 FTU. Turbidity (FTU) at the Chinka Bridge of Mukouhirose was 5.0 FTU, which was also higher than the water quality within the Saga Weir. It was lower than the turbidity (10.3 FTU) in the Iechi River. However, the prediction that turbidity would be lower because it was downstream of the weir did not hold true.

Photograph 7: View from the Chinka Bridge in Mukouhirose toward the downstream
At first glance, it appears to be a typical clear stream of the Shimanto River, but the turbidity (FTU) is very high at 5.0 FTU and it is polluted.
