## **Shimanto River Environmental Survey**

**4-5 July 2022**

### **Survey of Shimanto River Lower Reaches and Nishi Tosa Area**

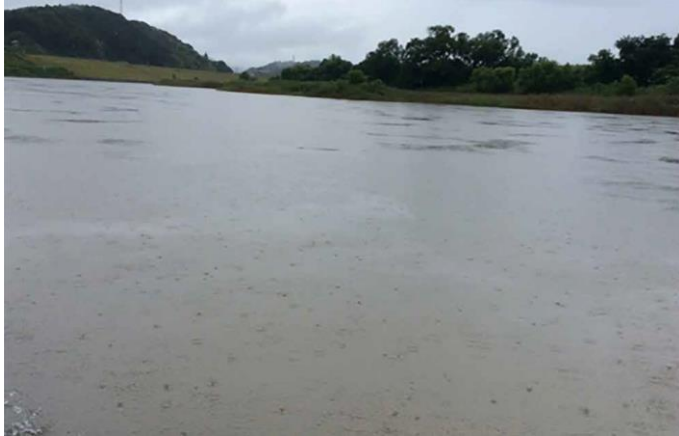
Muddy water at the confluence of the Nakasuji River and the main stream of the Shimanto River and rainfall on the river surface on July 4, 2022, 9:35 am

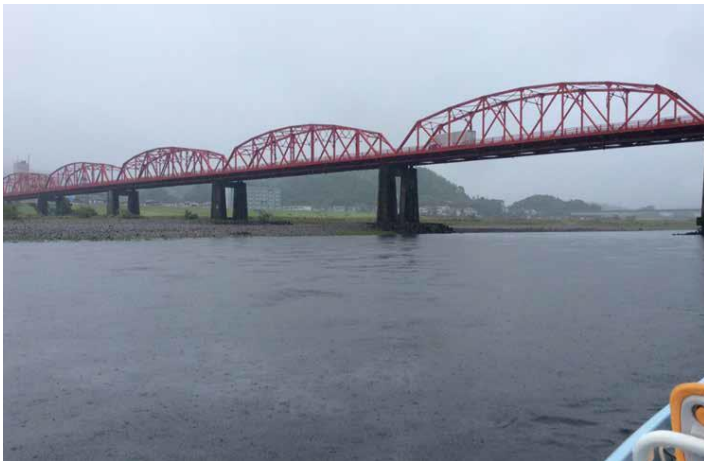
Akatetsu Bridge and rainfall viewed from the left bank to the right bank

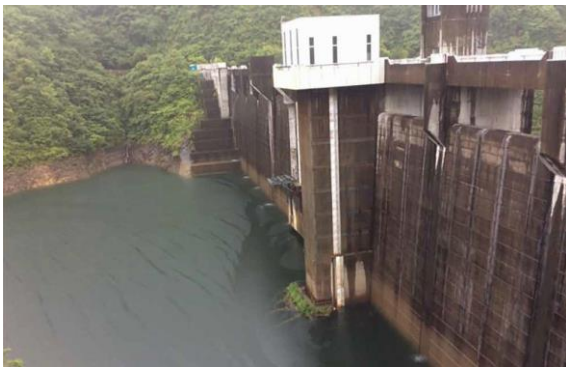
The embankment is 73.1 m high, the crest length is 217.5 m, the total volume is 274,000 m<sup>3</sup>, and the effective water storage capacity is 12 million tons. The flood storage capacity is 86 million tons.

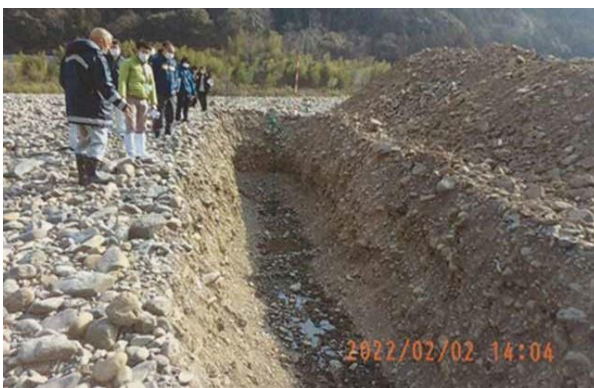
Excavation of riverbed near the Egawasaki Iwama Chinka Bridge, no underground water. Photographs of materials provided by Mr. Mitsuhiro Kanaya, President, Shimanto River West Fishery Cooperative Association; surveyed on February 2, 2022.

- Excavation at Egasaki in the midstream area revealed that there was no underground water flowing into the riverbed. This is presumably due to soil cavity closure caused by the increased turbidity mentioned above and loss of soil cavities due to the killing of soil bacteria from years of pesticide use.

On 2 February 2022, Mr. Mitsuhiro Kanaya, the president of the association, conducted excavation work on the riverbed near Egawasaki in the middle basin of the Shimanto River. The excavation work was carried out in three locations near the riverbank near the Iwama Chinka Bridge (Mebu area) and two weeded areas on the mountain side of the riverbed. The depth of excavation was approximately 2 meters, and no subsoil water was observed (see note).

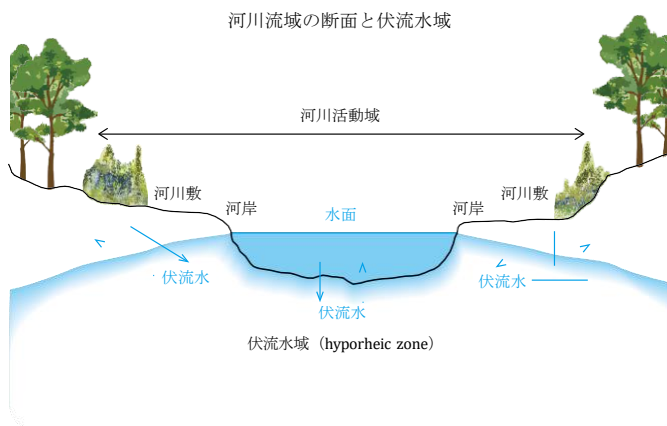
## Cross-section of river basin and subsoil waters

The subsoil water is not reaching the riverbed. Judging from this, it can be analogously concluded that although subsoil water also flows under the riverbed (see Figure 3), there is a large possibility that this too is blocked.

River water flowing from the land to the sea through a river conveys water under the riverbed, along the banks of the river, or on the floodplain, and then flows back into the main stream of the river. This is called the hyporheic zone. The banks and floodplains contain microscopic holes and cavities into which river water flows and undergoes decomposition by microorganisms and bacteria to break down chemical substances and produce organic nutrients. Banks and floodplains also retain large amounts of rainwater that cannot be treated by rivers. In the U.S., the function of banks and floodplains is to retain large volumes of rainwater that cannot be treated by rivers. In the United States, the function of banks and floodplains is scientifically evaluated based on hydraulic conductivity (volume and velocity), soil accumulation (sediment), and soil texture.
